Extending an Aerial Remote Sensing Platform Using Three Digital Sensors—
Summary Report to MASTS TPS

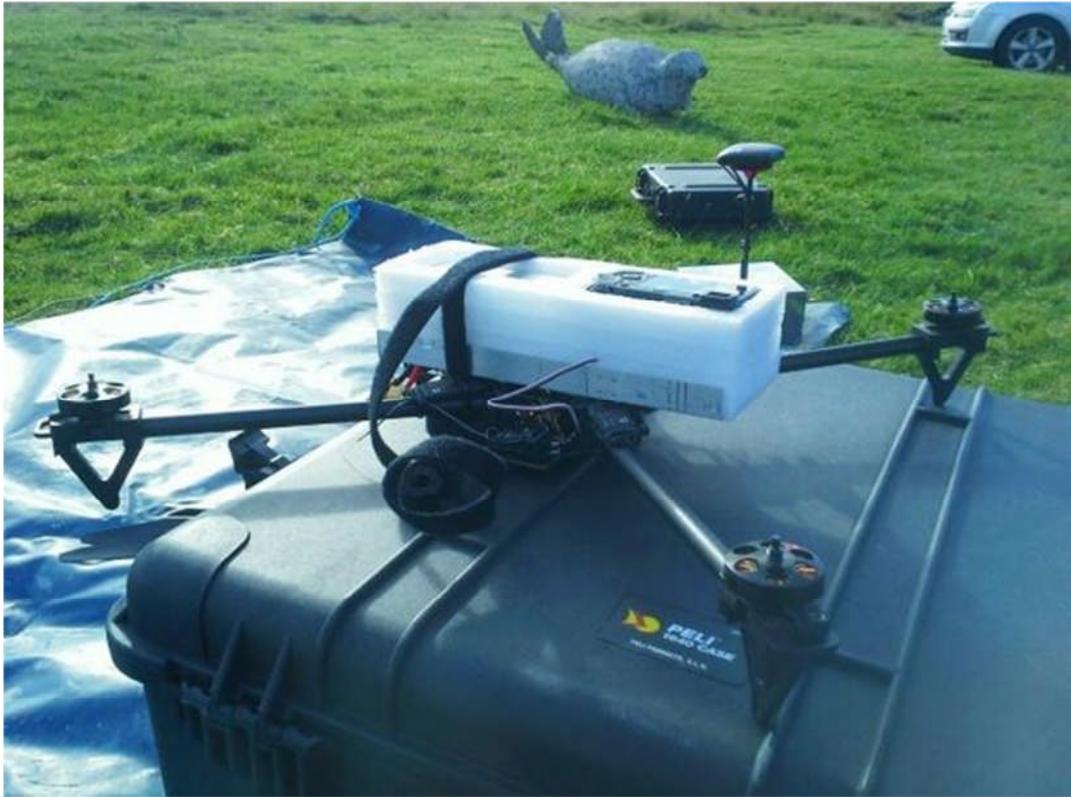
Figure 3. Bespoke UAV with Styrofoam seal in background.

In terms of the improvement and reliability of the measurements of the animals, we had a Master's student (Marie Kearns) work on this as part of the MRes program in Marine Mammal Science at University of St Andrews. To test the impact of the sensor on the final measurements, we flew the UAV over a Styrofoam seal of known length (Figures 3, and 4). Length measurements of the seal as determined using the rangefinder-derived altitude readings were both more precise and more accurate than either of the two onboard methods (Figure 5). Going forward then, we have every confidence that this sensor is an important part of a UAV platform, and should be included when altitude measurements are critical.

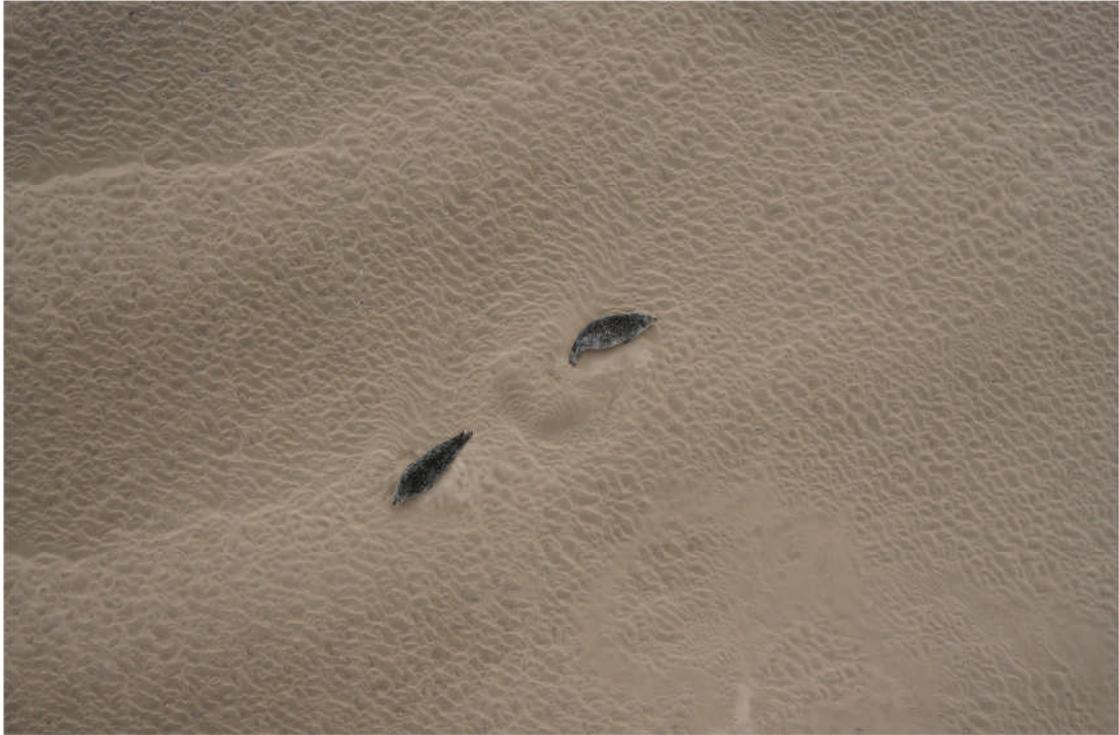
Figure 7. Example picture taken at Loch Fleet on May 26, 2016. The UAV was equipped with the FPV setup, the laser rangefinder, and the 3-axis gimbal. Note how the FPV camera allows for near perfect placement of the seal in the image.

Despite these issues, the inclusion of the FPV on the UAV allowed for very accurate and precise placement of the UAV over the seal (Figures 7 & 8). Because of this, we are able to get more seals in the centre of each picture, thereby increasing precision and accuracy of the morphometric measurements.

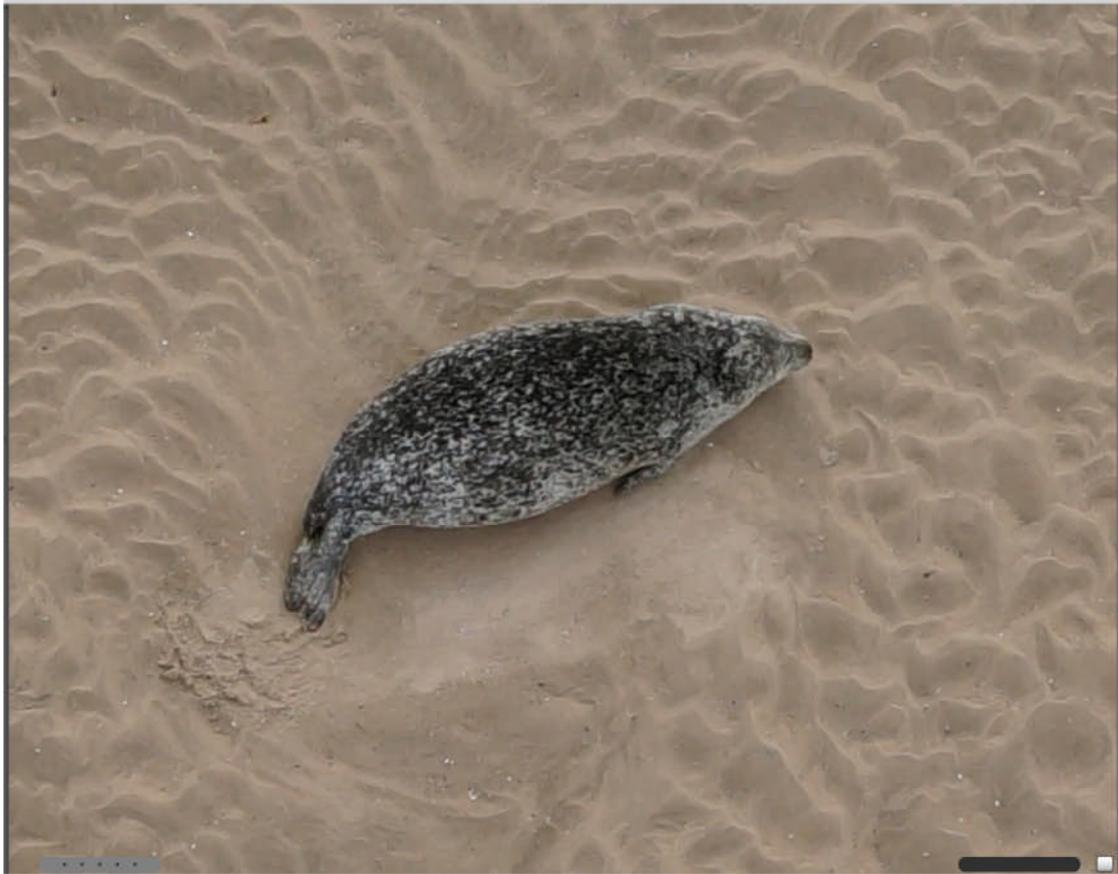
Figure 8. 100% zoom of the seal in the centre of the image of Figure 7. Because of the placement of the UAV with respect to the seal, the sharpness of the image, and the precision of the altitude measurements, this represents an ideal image capture. With this image we can not only measure the animal, but also can match it to the photographic catalog maintained by University of Aberdeen's Lighthouse Field Station.
